EVALUATION OF REDESIGNED XW18 MEMBRANE
AND ACCESSORIES

TECHNICAL REPORT S-73-3

Conducted by U. S. Army Engineer Waterways Experiment Station
Soils and Pavements Laboratory
Vicksburg, Mississippi

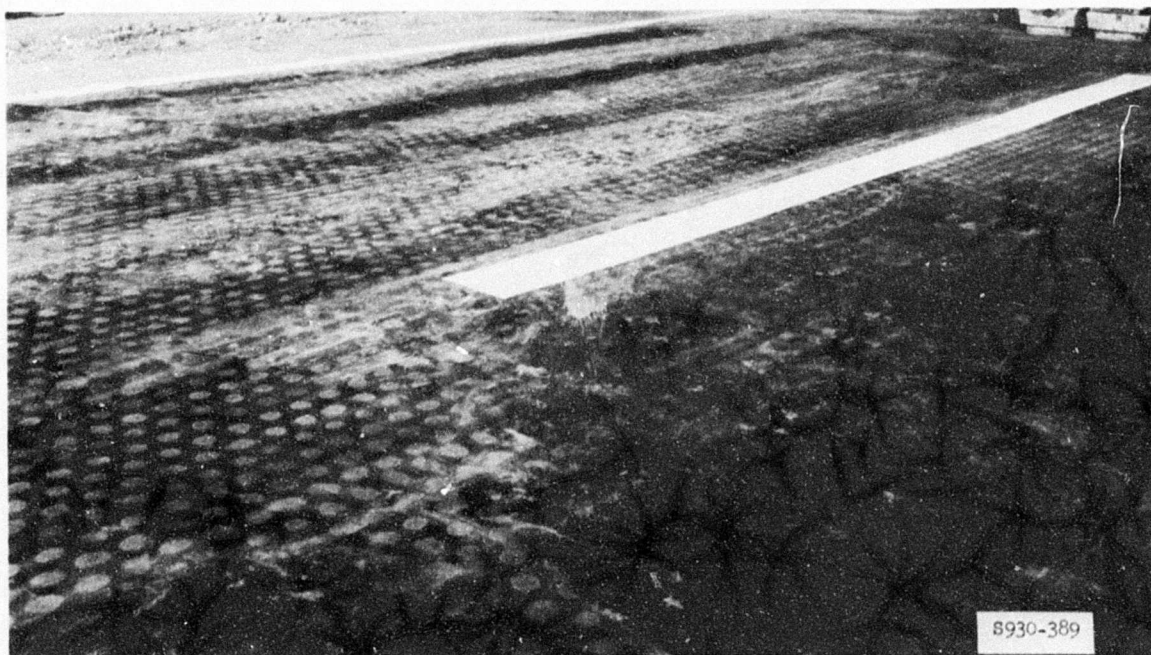
33. An examination of the surface after the skid tests revealed that approximately 36 percent of the nonskid compound was removed after the dry skids (photo 12) and approximately 23 percent was removed after the wet skids (photo 13). Cross sections of the surface made at 6-ft intervals and a center-line profile of a rut caused by a typical skid are shown in plate 6.

Photo 13. Nonskid removed after wet skid on XW18 membrane section 2

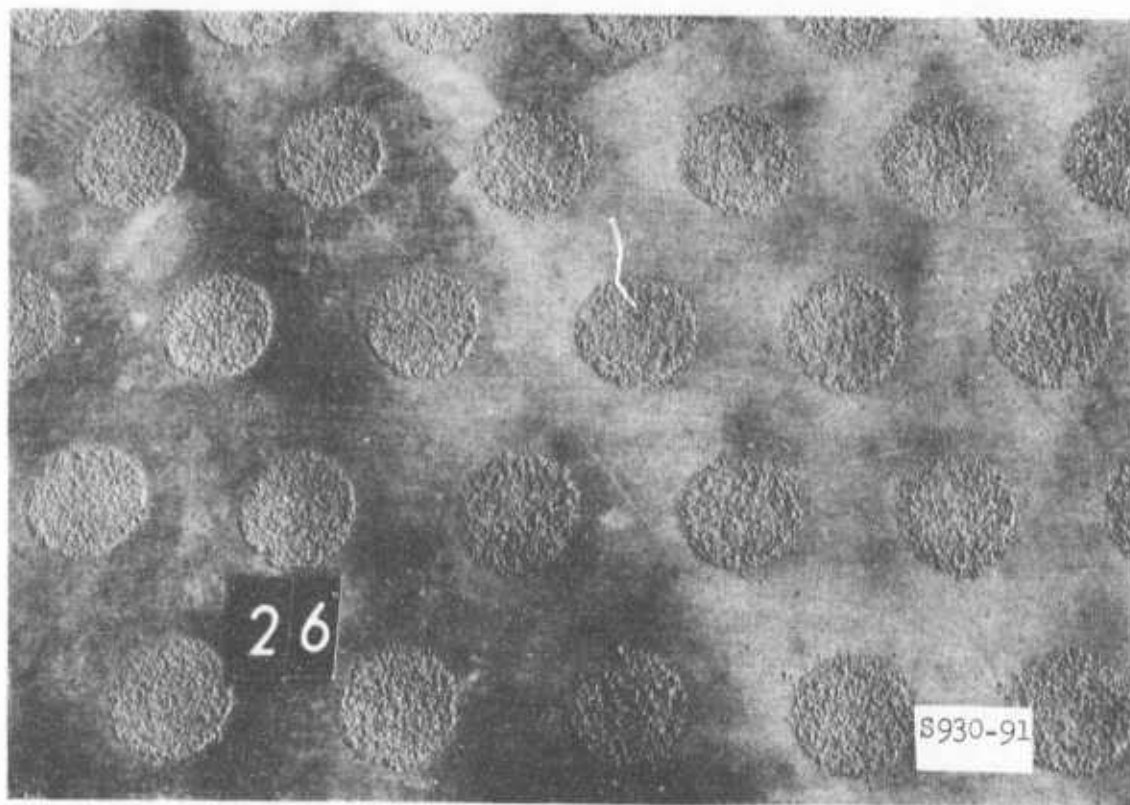
30. An examination of the surface after the skid tests revealed that approximately 97 percent of the nonskid compound was removed after the dry skids (photo 6) and approximately 59 percent was removed after the wet skids (photo 7). Cross sections of the surface made at 6-ft intervals and a center-line profile of a rut caused by a typical skid are shown in plate 5.

Photo 7. Removal of nonskid on XW18 membrane section 1
after one wet skid

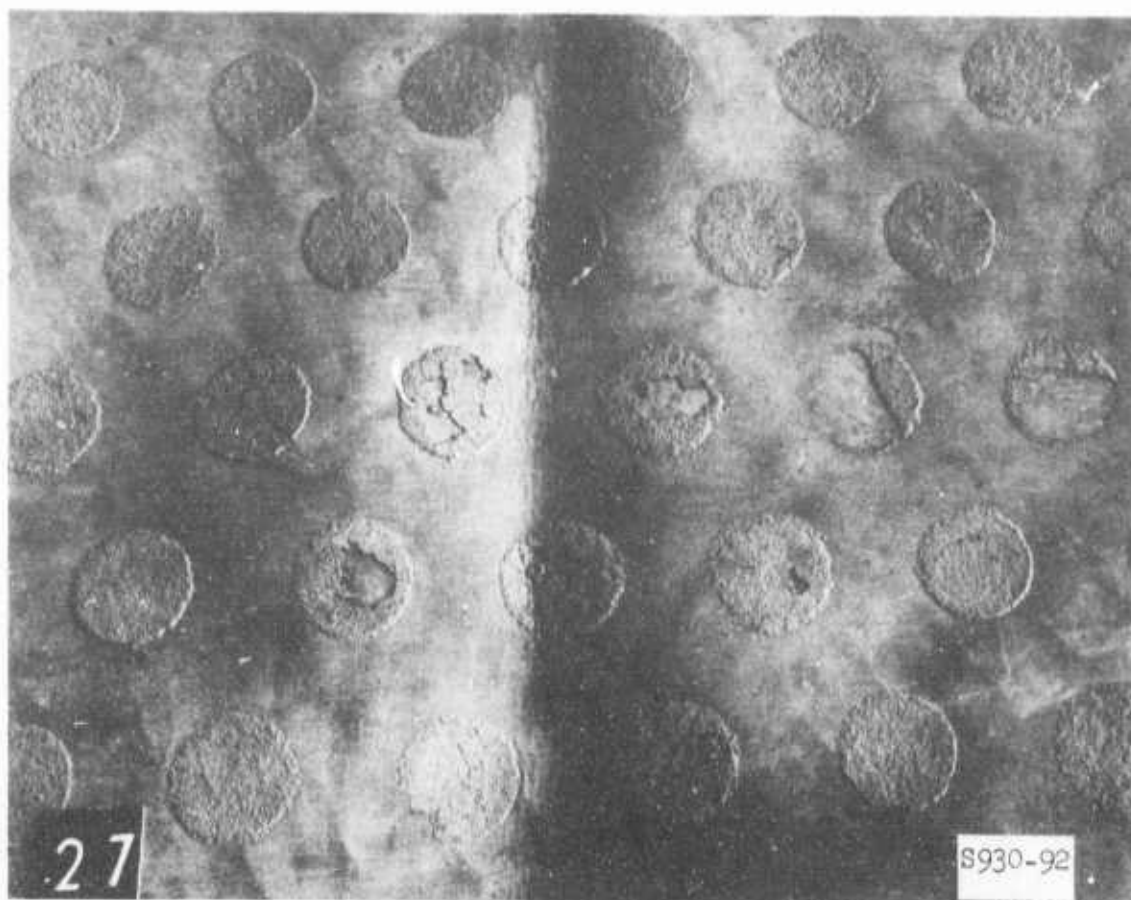
31. Test section 2. Photo 8 shows the general condition of the membrane surface prior to the skid tests. Partial cracking and flaking of the nonskid coating occurred in isolated areas (photo 9).

Photo 8. Condition of nonskid coating on XW18 membrane section 2
prior to skid tests

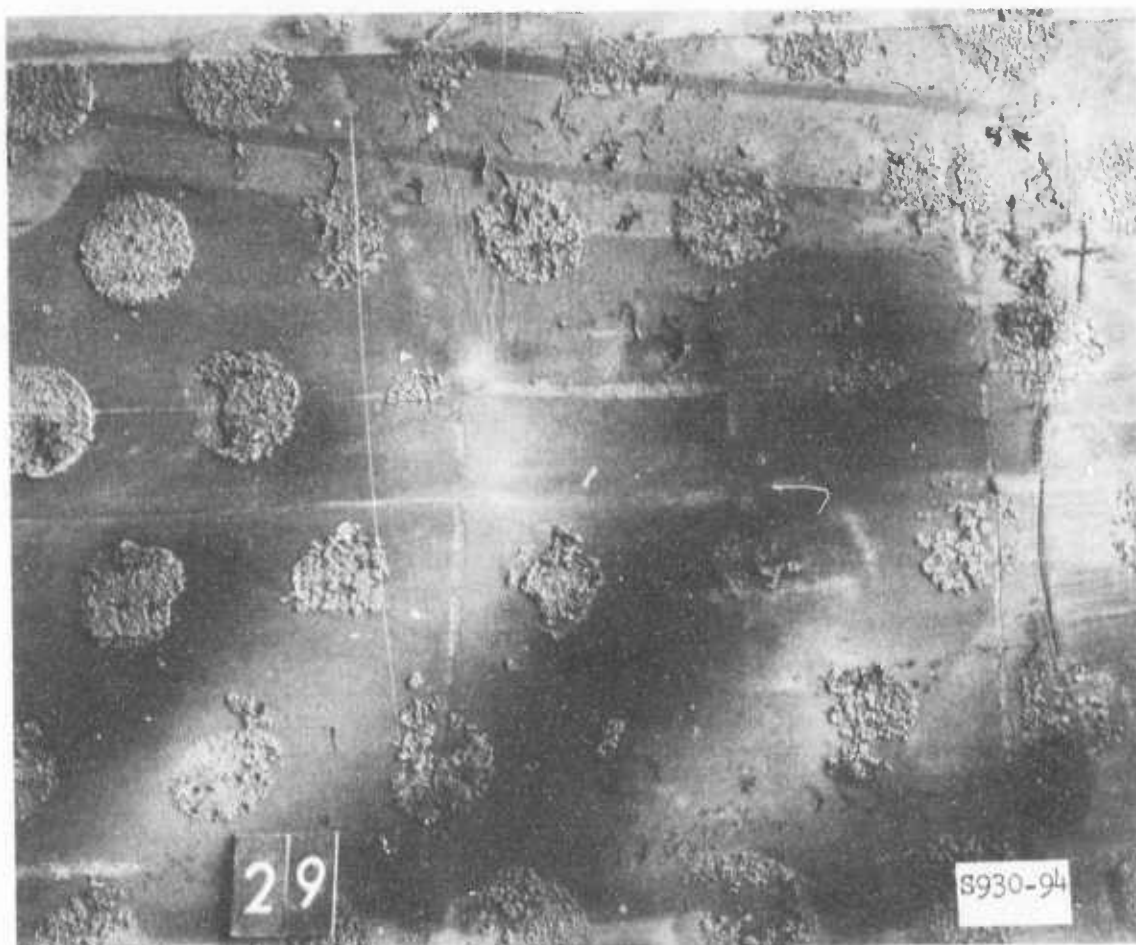
32. Photo 10 shows XW18 membrane test section 2 after four dry skids, and photo 11 shows the section after four wet skids. The average rated braking conditions for the dry and wet skids were 0.74 and 0.50, respectively (table 3), corresponding to dynamic coefficients of friction of 0.59 and 0.45, respectively.

Photo 11. Condition of XW18 membrane section 2 after four wet skids

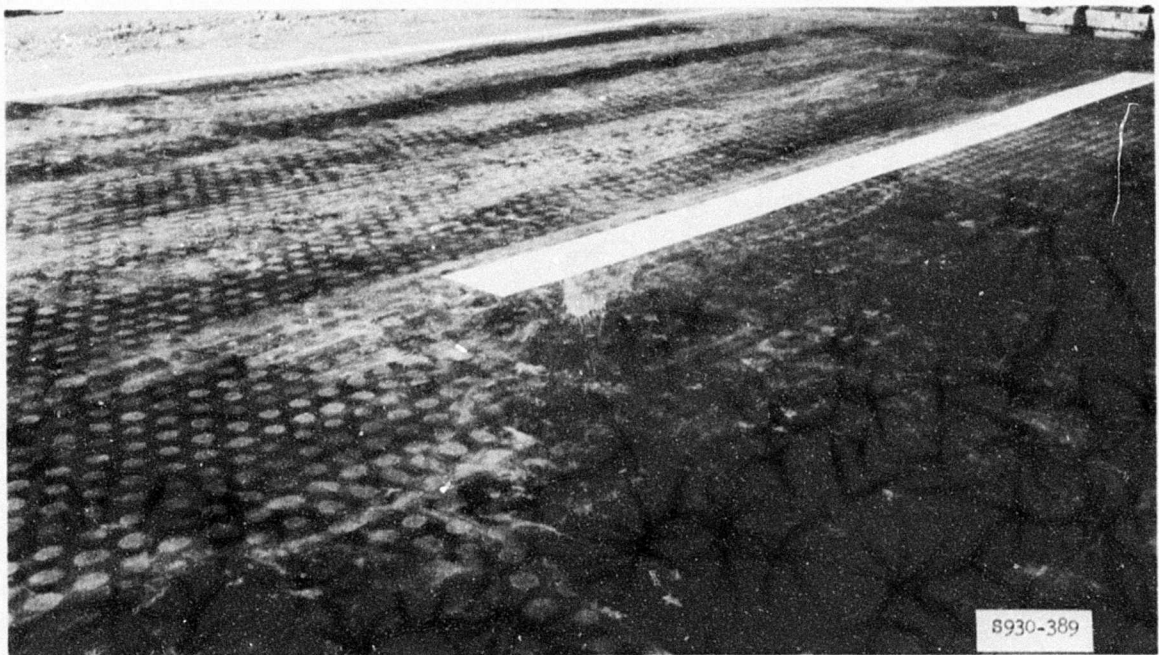
Photo 13. Nonskid removed after wet skid on XW18 membrane section 2

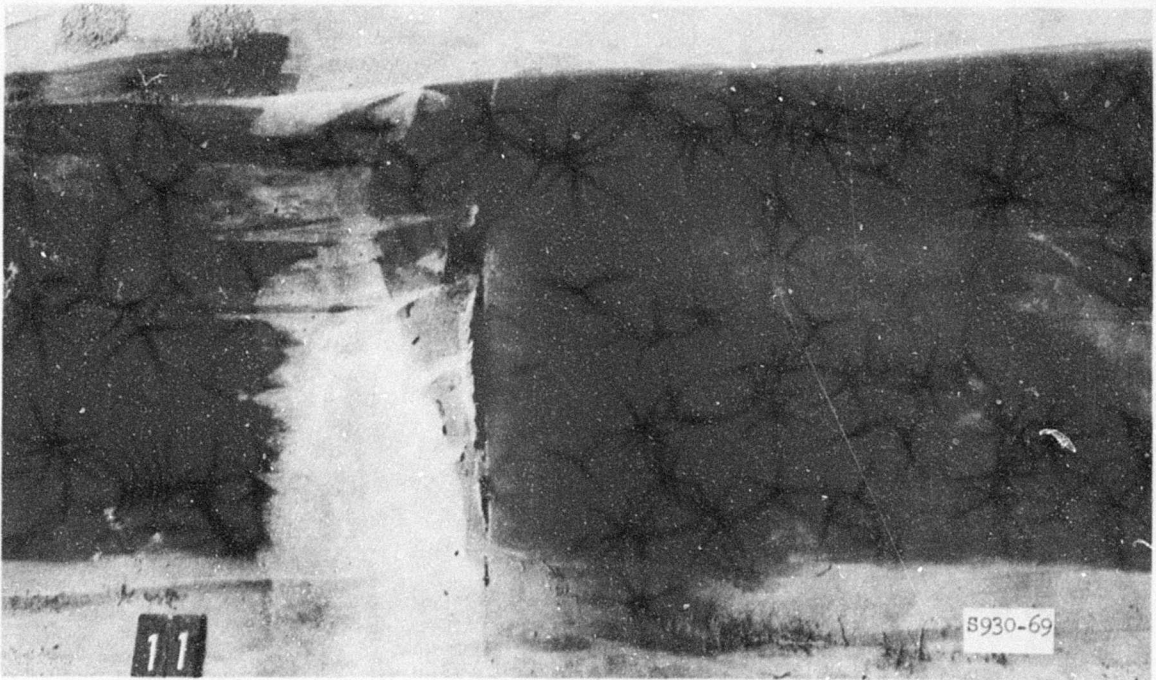
35. The condition of XW18 membrane test section 3 after four dry and four wet skids (photo 14) was similar to that described for test sections 1 and 2. The average rated braking conditions for the dry and wet skids were 0.72 and 0.50, respectively (table 3), corresponding to dynamic coefficients of friction of 0.63 and 0.41, respectively.

Photo 14. Condition of XW18 membrane section 3 after four wet and four dry skids

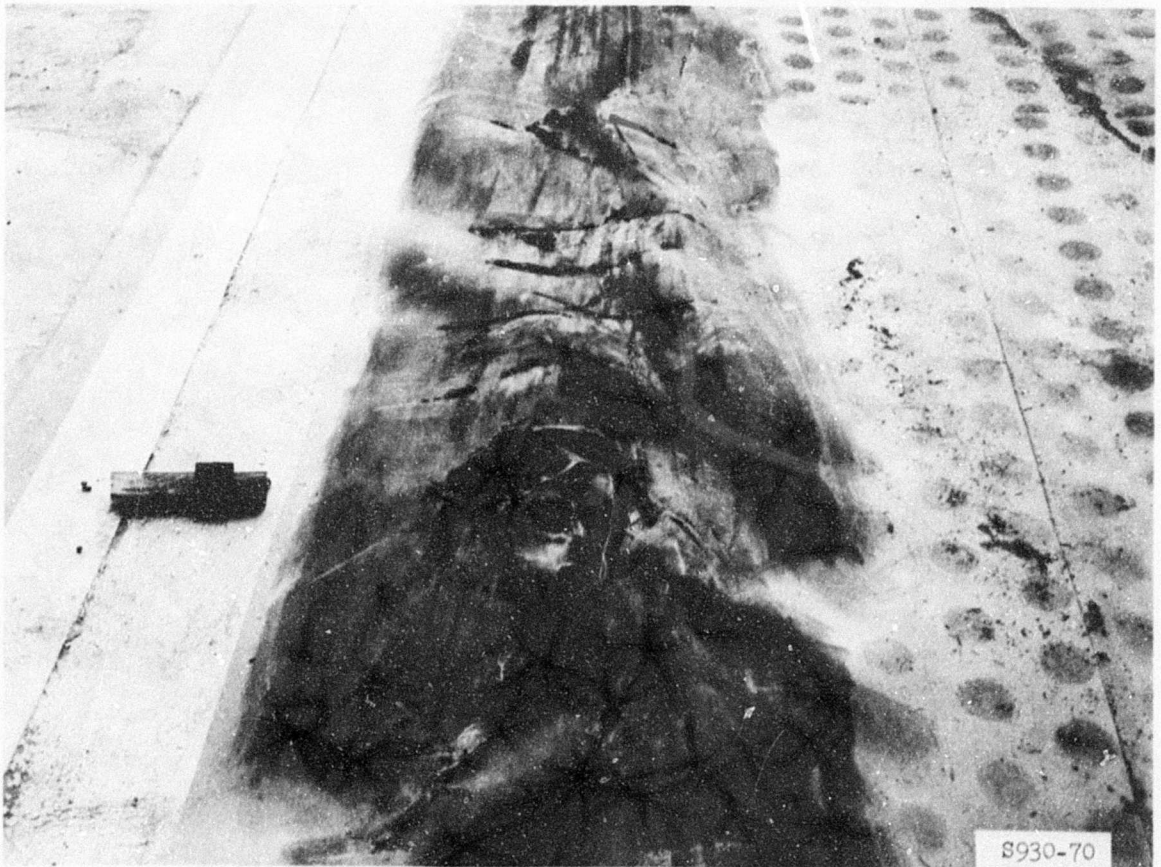
- a. Run 1. After the second repetitive skid on the same area of run 1, the top ply of nylon fabric failed in nine places (photo 15). This fabric failure was not considered to constitute a complete failure of the membrane, since three plies of fabric remained to waterproof the subgrade. The severity of top-ply failures increased during subsequent skids. Photo 16 shows the membrane after six repetitive skids had been completed. However, only top-ply failures had occurred. Complete failure of the membrane

Photo 15. Failure of top ply of nylon fabric of run 1 of XW18 membrane section 1 after second repetitive skid

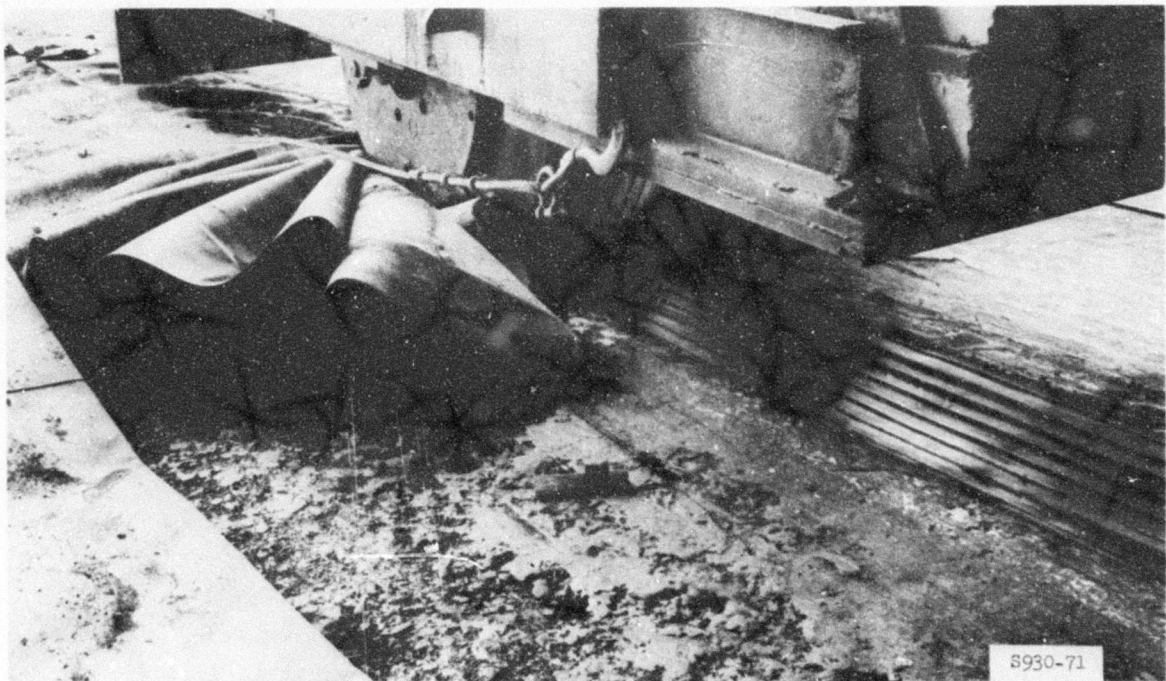
Photo 16. Extensive top-ply failures after sixth repetitive skid on run 1 of XW18 membrane section 1

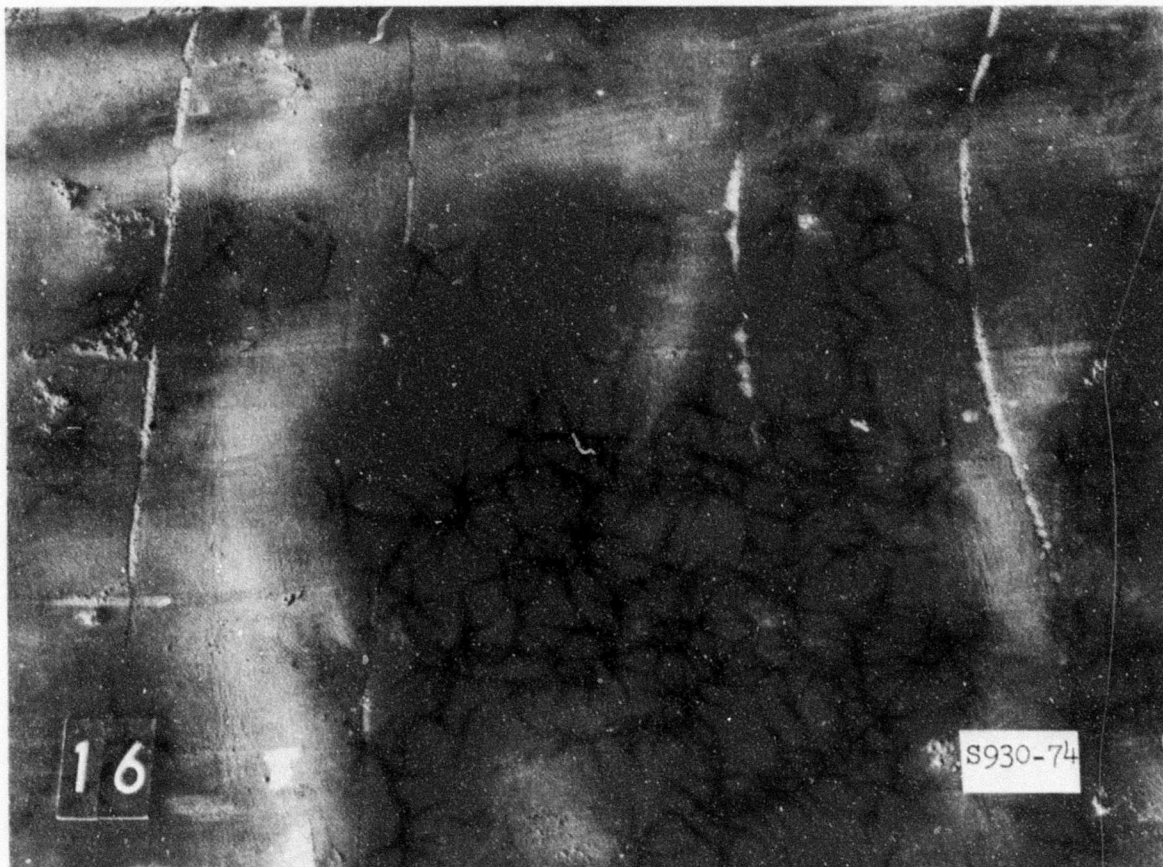
occurred when an attempt was made to skid the test wheel over the same area of run 1 for the tenth time. The membrane failure was in a U-shaped 12- by 13-ft area (photo 17). Cross sections of the surface taken at 6-ft intervals and a center-line profile of the rut caused by the tire skidding are shown in plate 8. These cross sections and the profile show typical rutting incurred by the subgrade during the three failure point determinations made on XW18 test section 1.

Photo 17. Failure of run 1 of XW18 membrane section 1 after ten repetitive skids

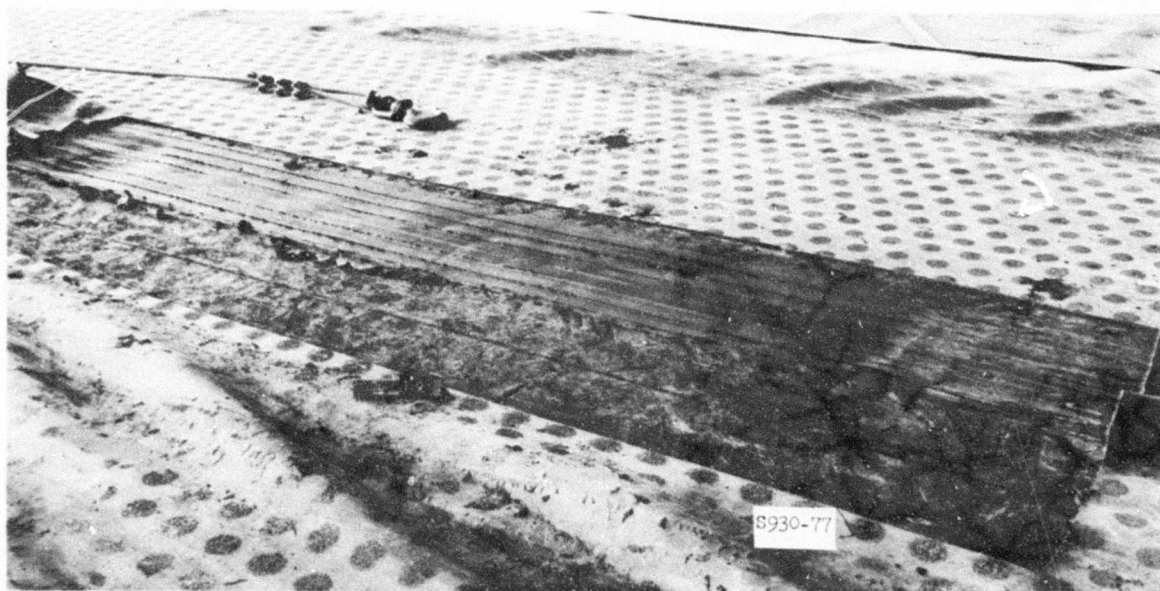
- b. Run 2. After the second repetitive skid across the same area of run 2, only small amounts of neoprene had been stripped from the surface (photo 18). No top-ply failures occurred at this time as they had on run 1. No change in the condition of the membrane was evident following the third repetitive skid. However, during the fourth skid, the membrane failed after the tire had skidded a distance of approximately 2 ft. The failure extended completely across the run (approximately 4 ft) and was 12 ft long (photo 19). As is evident in photo 19, rutting of the subgrade was negligible.

Photo 18. Condition of surfacing after second repetitive skid on run 2 of XW18 membrane section 1

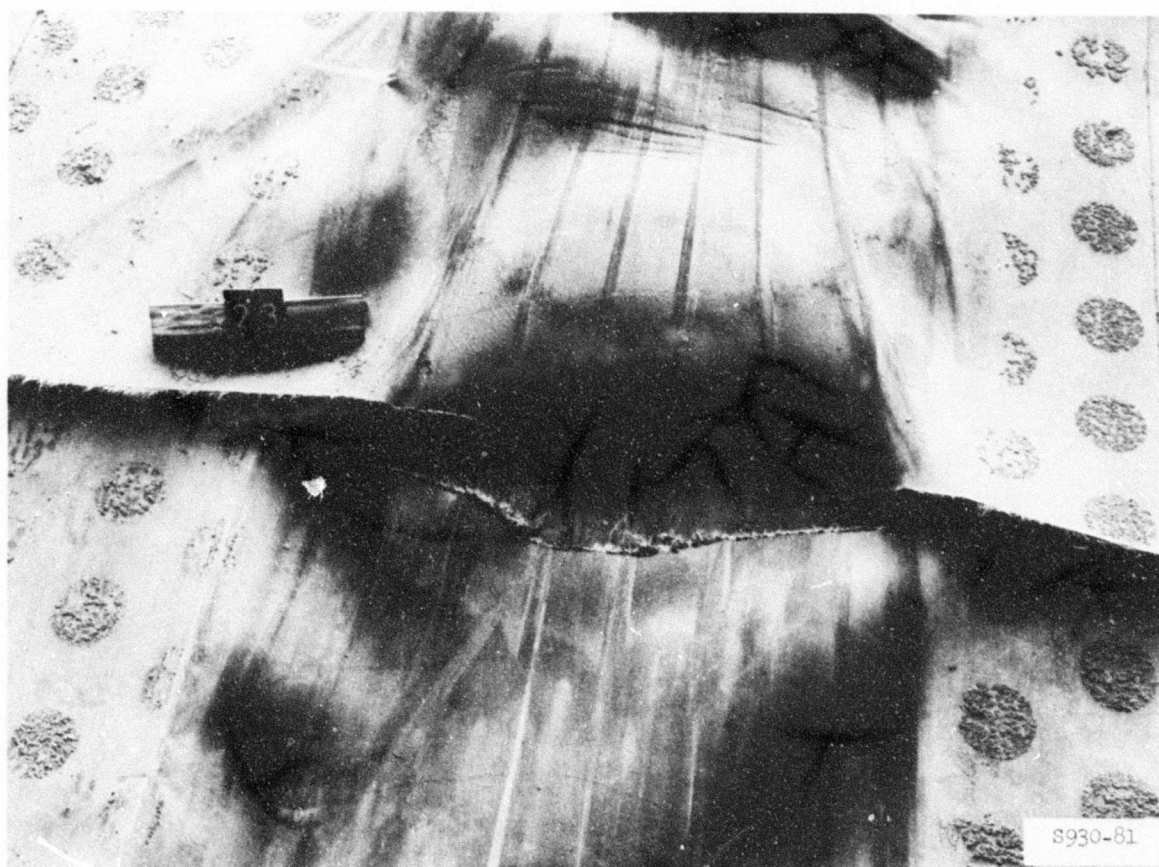
Photo 19. Failure of run 2 of XW18 membrane section 1

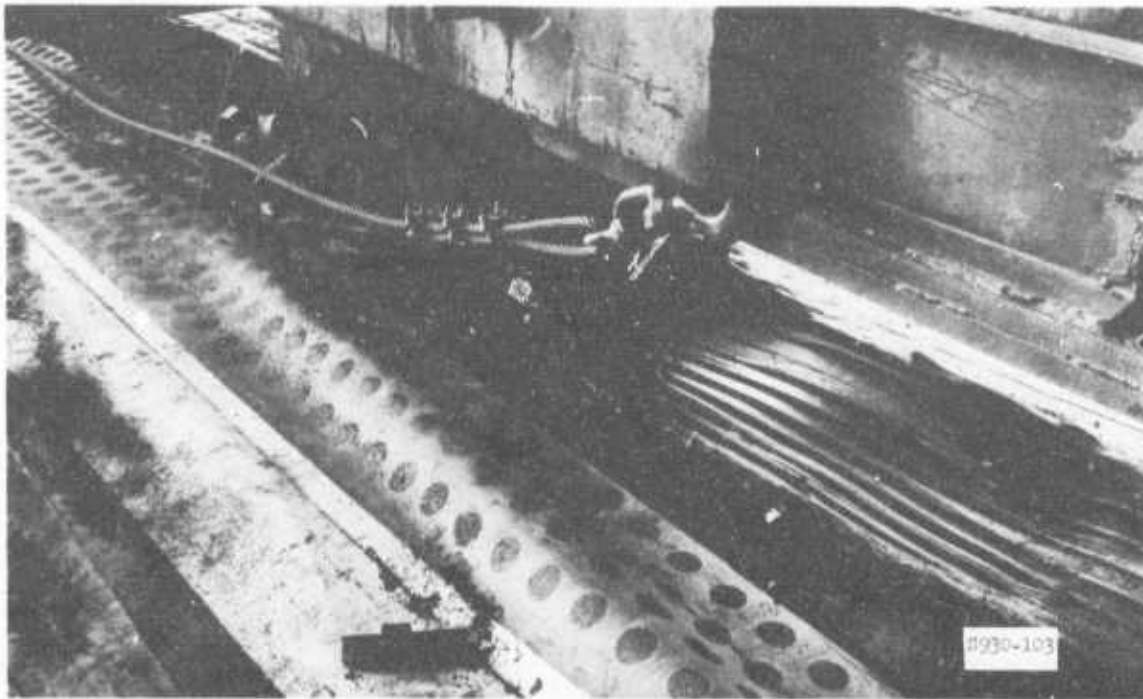
- c. Run 3. Top-ply fabric failures occurred at two places in run 3 after the second repetitive skid. These types of failures increased in number during subsequent skids. During the fifth repetitive skid, complete failure of the membrane occurred after a skid of approximately 2 ft. The failed area was 16 ft wide and 6 ft long (photo 20).

Photo 20. Failure of run 3 of XW18 membrane section 1

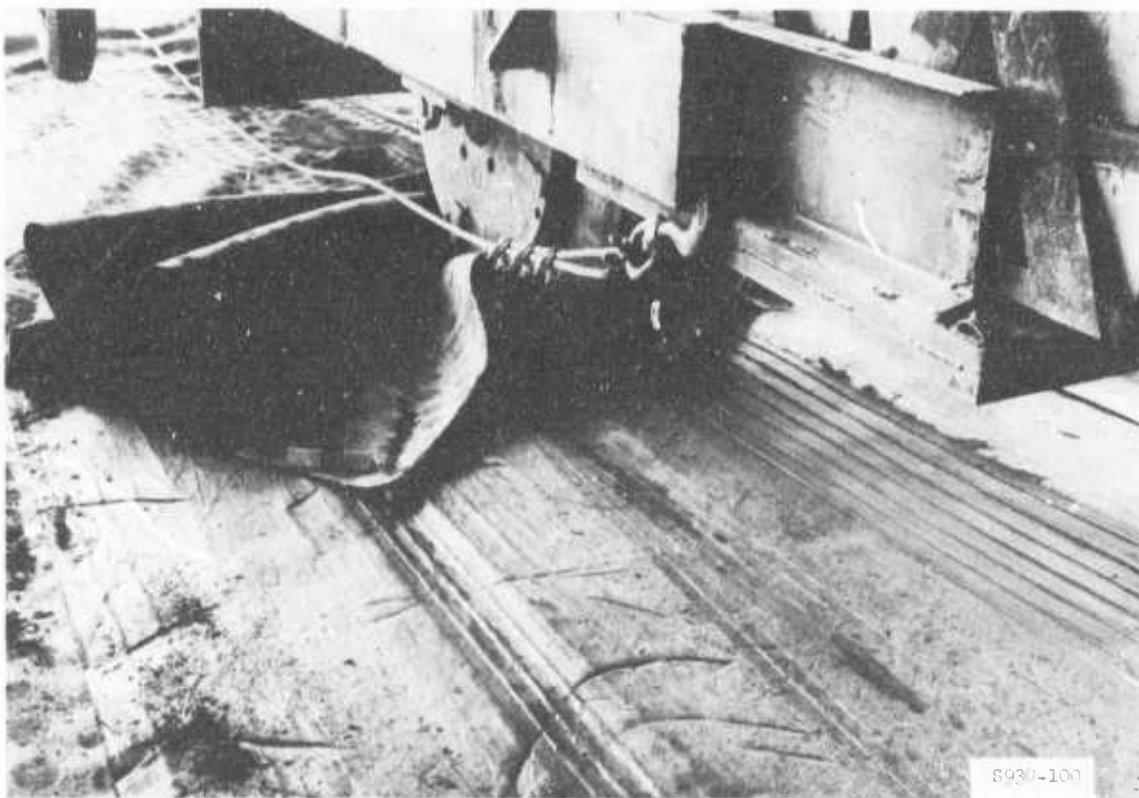
- a. Run 1. Top-ply failures occurred after two repetitive skids and increased in number and severity during subsequent skids. Complete failure of the membrane occurred approximately 2 ft after the initiation of the eighth skid in an area 4 ft wide and 9 ft long (photo 21). As is shown in photo 21, rutting of the subgrade was somewhat more severe than during previous tests. Cross sections of the surface taken at 6-ft intervals and a center-line profile of the rut caused by the skidding are shown in plate 9.

Photo 21. Failure of run 1 of XW18 membrane section 2 after eight repetitive skids

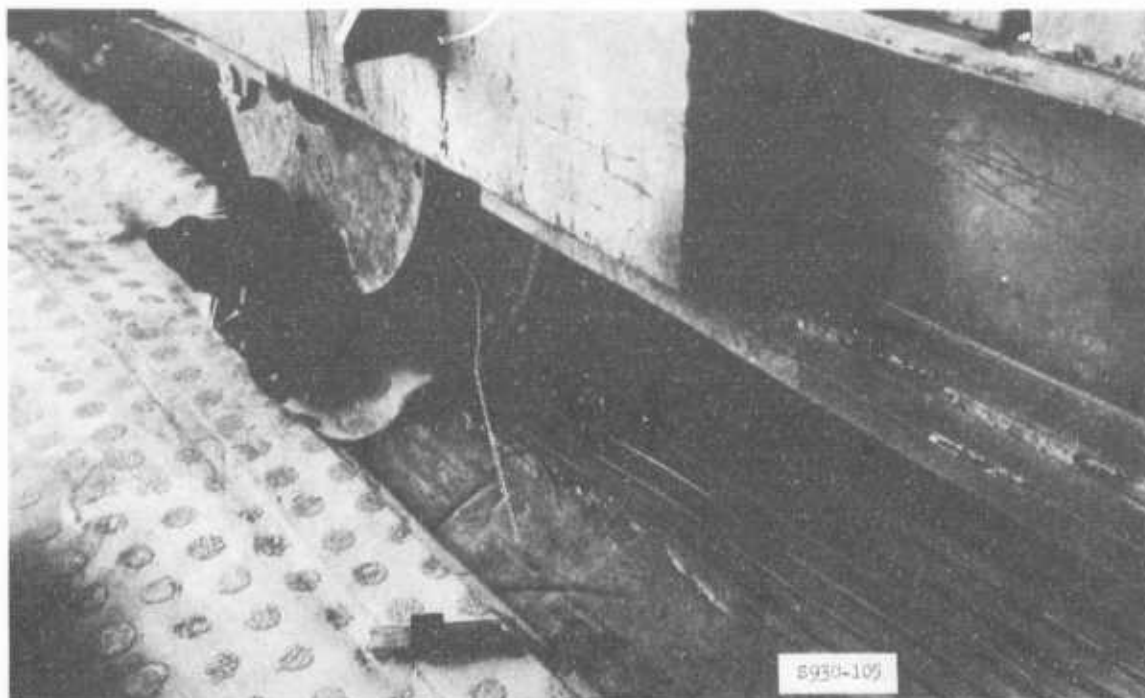
- b. Run 2. Three repetitive skids over the same area of run 2 were required to completely fail the membrane. The area of failure extended across two runs of the membrane (approximately 7-1/2 ft) and was 8 ft long (photo 22). The failure developed before the test wheel began to skid, and it occurred in an area where no top-ply failures had been observed previously.

Photo 22. Failure of run 2 of XW18 membrane section 2 after three repetitive skids

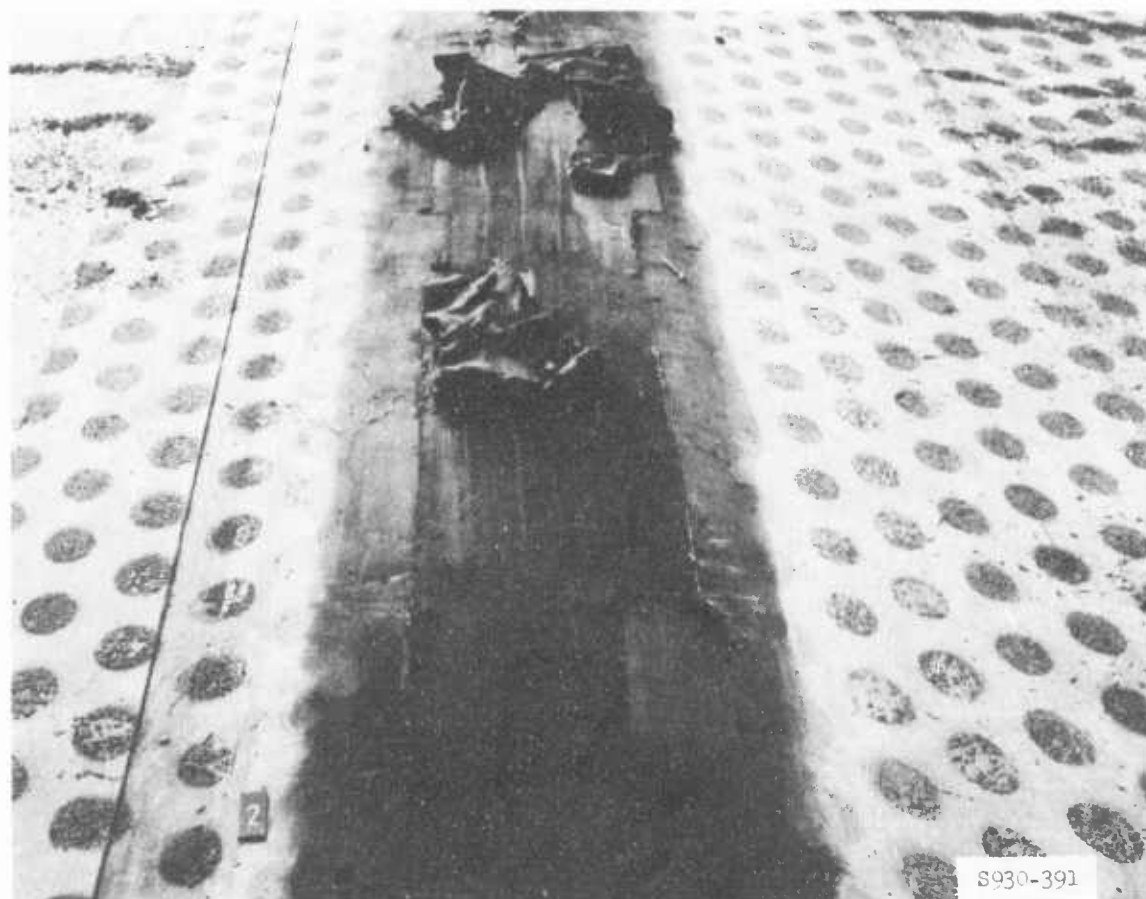
area that had been weakened by such failures. After six repetitive skids, the membrane failed completely in a 7-1/2-ft-wide by 8-1/2-ft-long area (photo 23).

Photo 23. Failure of run 3 of XW18 membrane section 2 after sixth repetitive skid

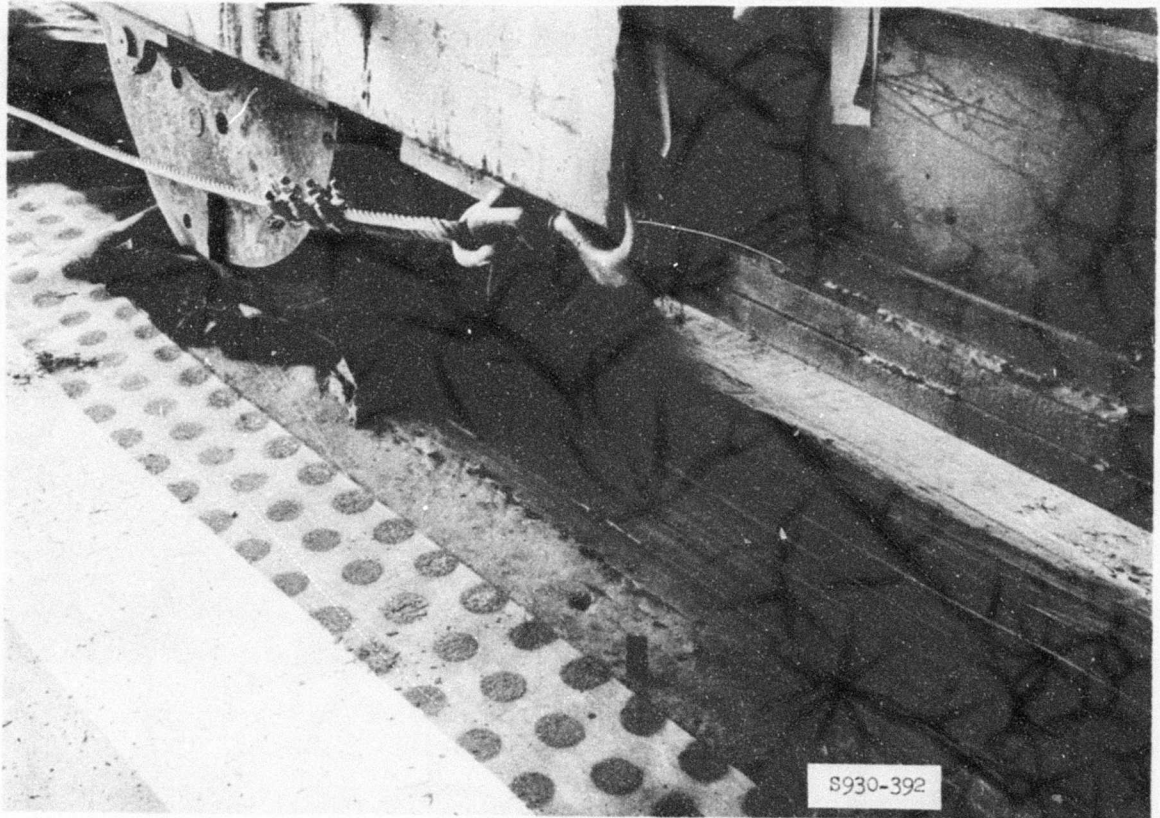
- a. Run 1. Top-ply failures occurred during the third skid and increased in number during subsequent skids (photo 24). In an area where the membrane had been weakened by these failures, complete failure of the membrane occurred 3 ft after the beginning of the seventh skid. The area failed was 4 ft wide and 8 ft long (photo 25). Cross sections of the surface taken at 6-ft intervals and a center-line profile of the rut caused by the skidding are shown in plate 10.
- b. Run 2. Top-ply failures occurred after three repetitive skids. During the eighth skid, several second-ply failures occurred (photo 26), leaving the membrane with only half of its original strength. Complete failure of the membrane occurred during the tenth skid. The area failed was 4 ft wide and 8 ft long (photo 27). As is shown in plate 11, rutting of the subgrade was quite severe.

Photo 24. Condition of run 1 of XW18 membrane section 3 after six repetitive skids

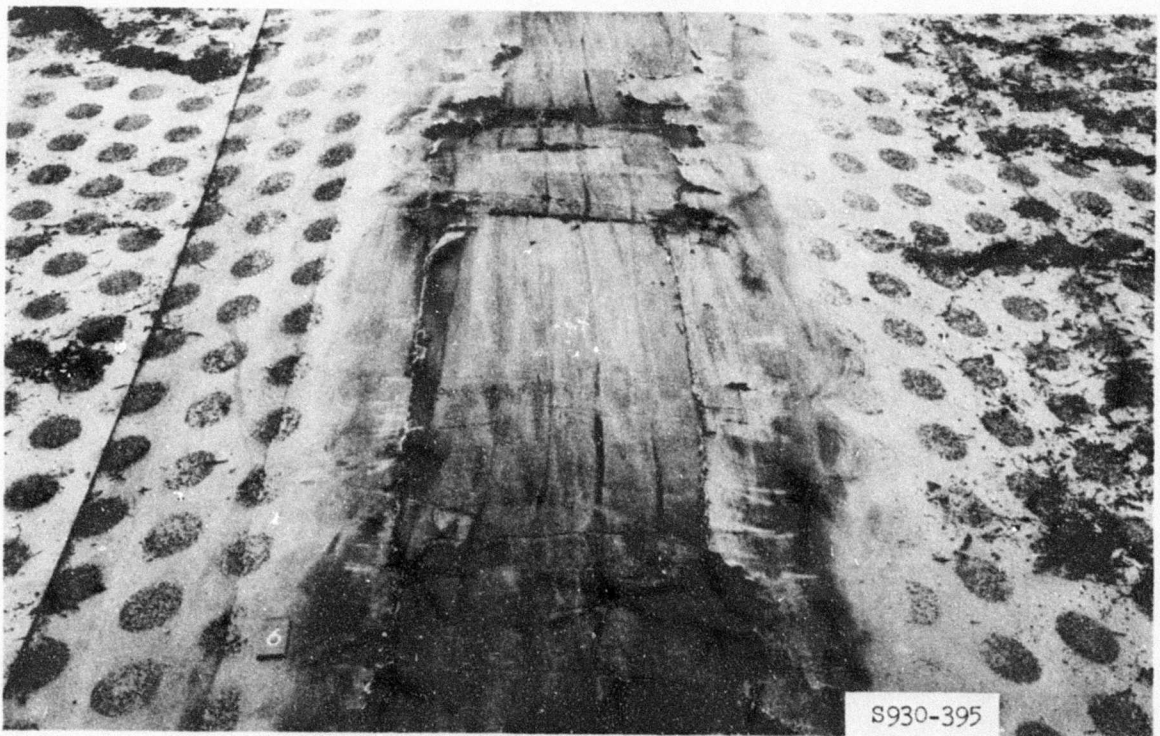
Photo 25. Failure of run 1 of XW18 membrane section 3 after seven repetitive skids

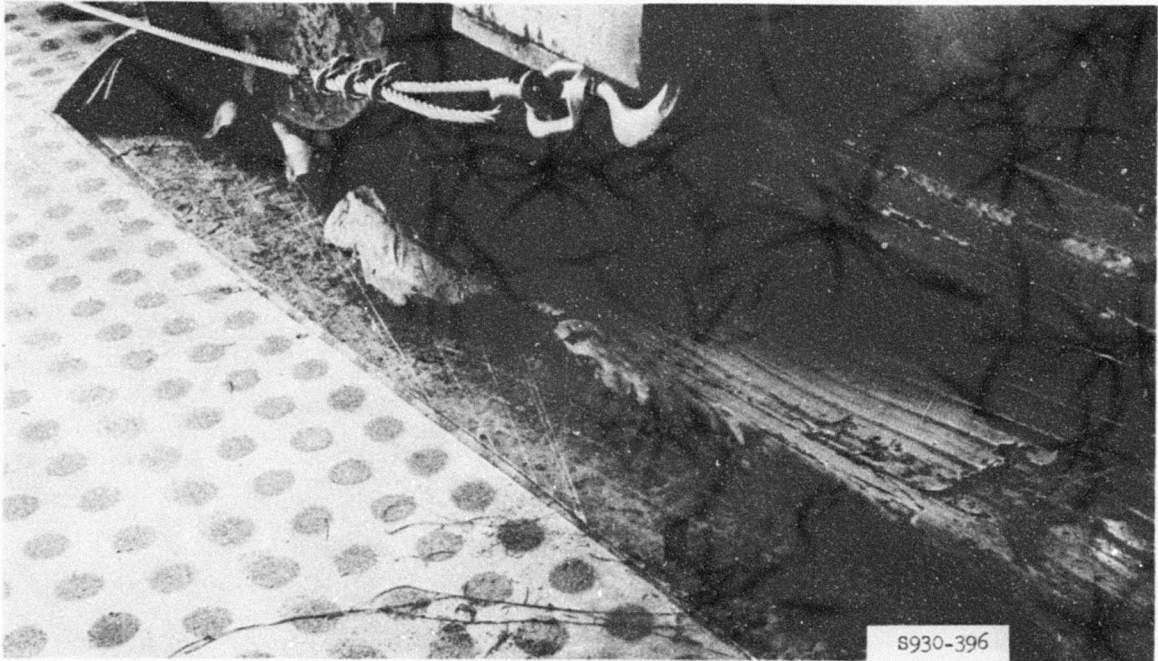
Photo 26. Second-ply fabric failures on run 2 of XW18 membrane section 3 after eighth repetitive skid

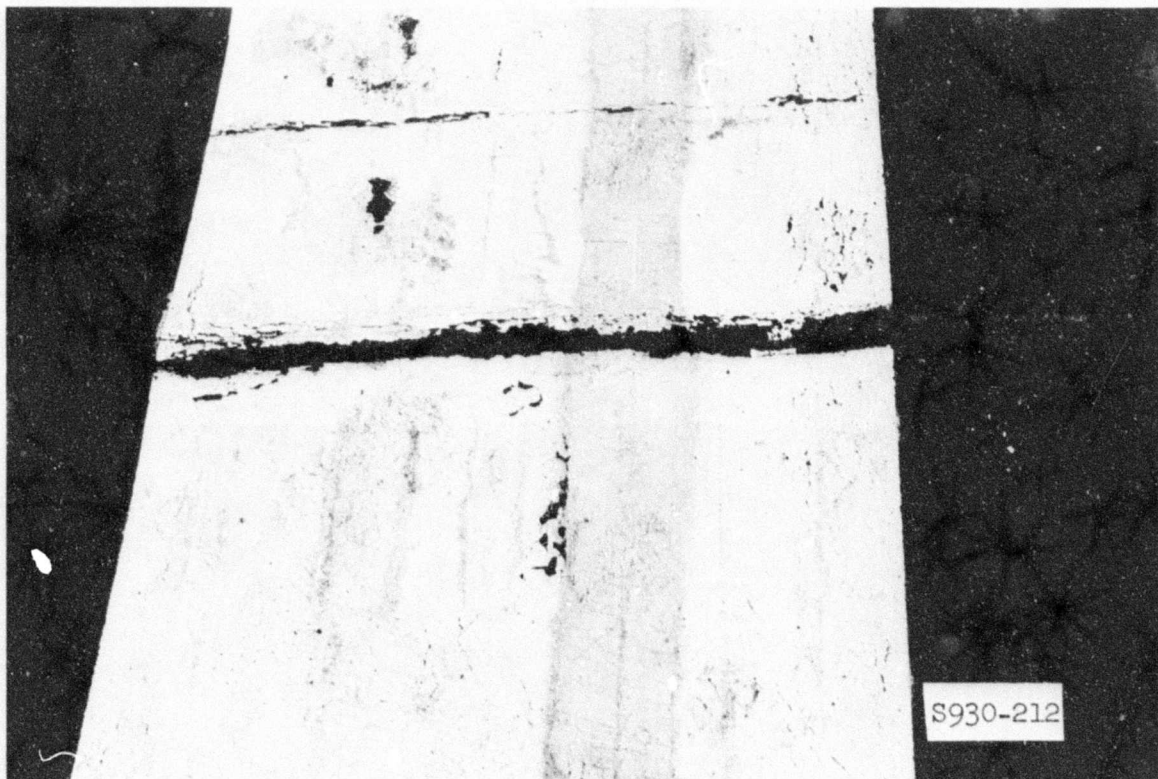
Photo 46. Heavy wear on edges of folds in surfacing caused by test wheel (100 coverages on test section 1)

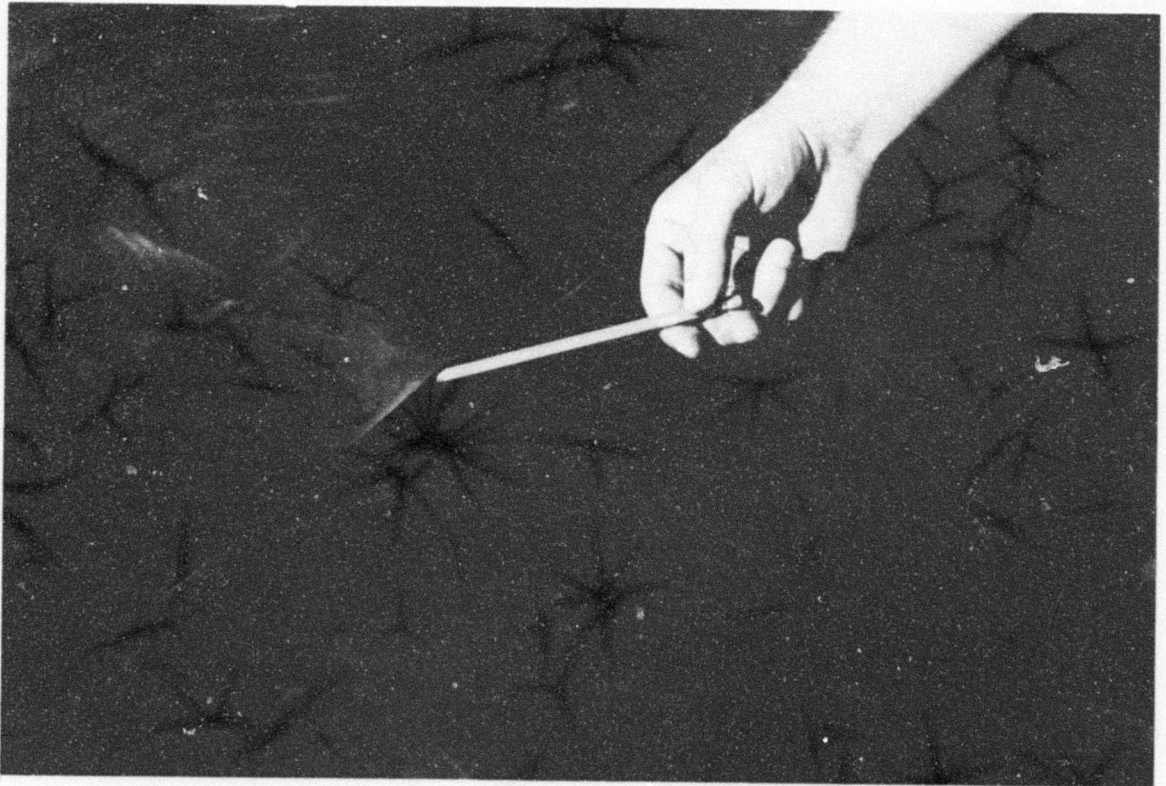
Photo 47. Edge of 3-ft-wide reinforcing strip on adhesive construction joint worked loose by test wheel (100 coverages on test section 1)

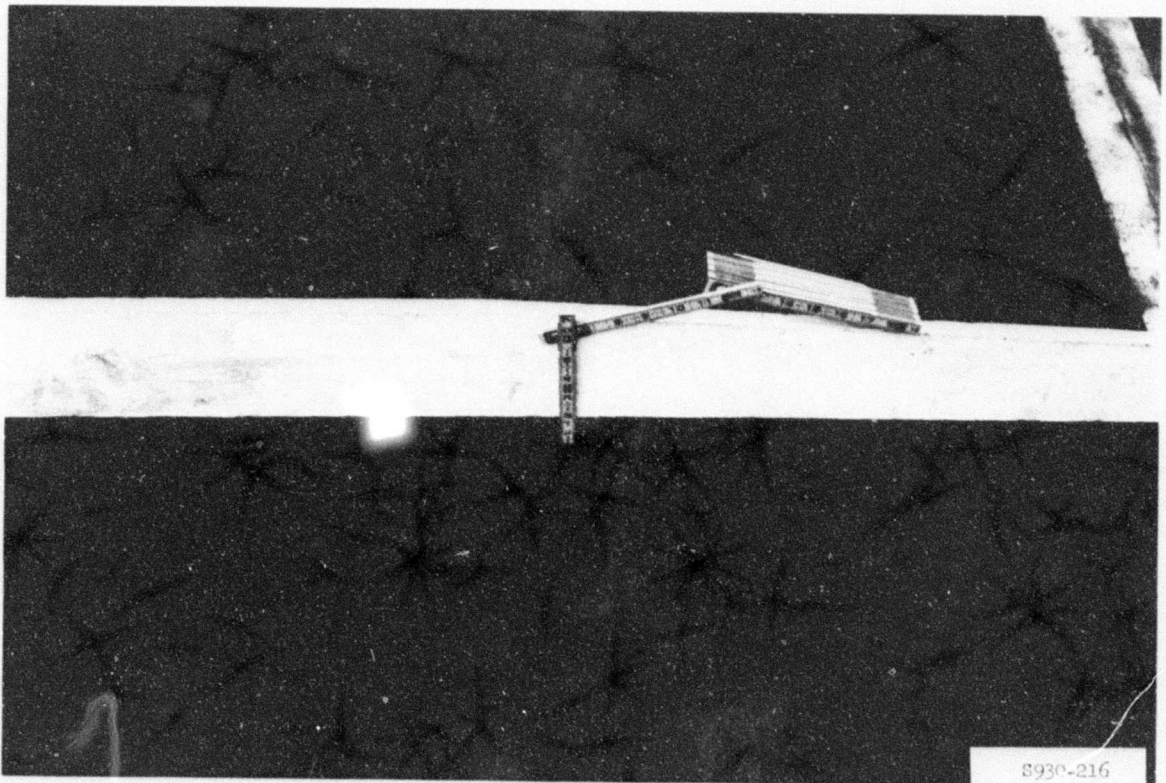
Photo 48. Two-in. rutting of subgrade after 150 coverages (test section 1, sta 0+75)

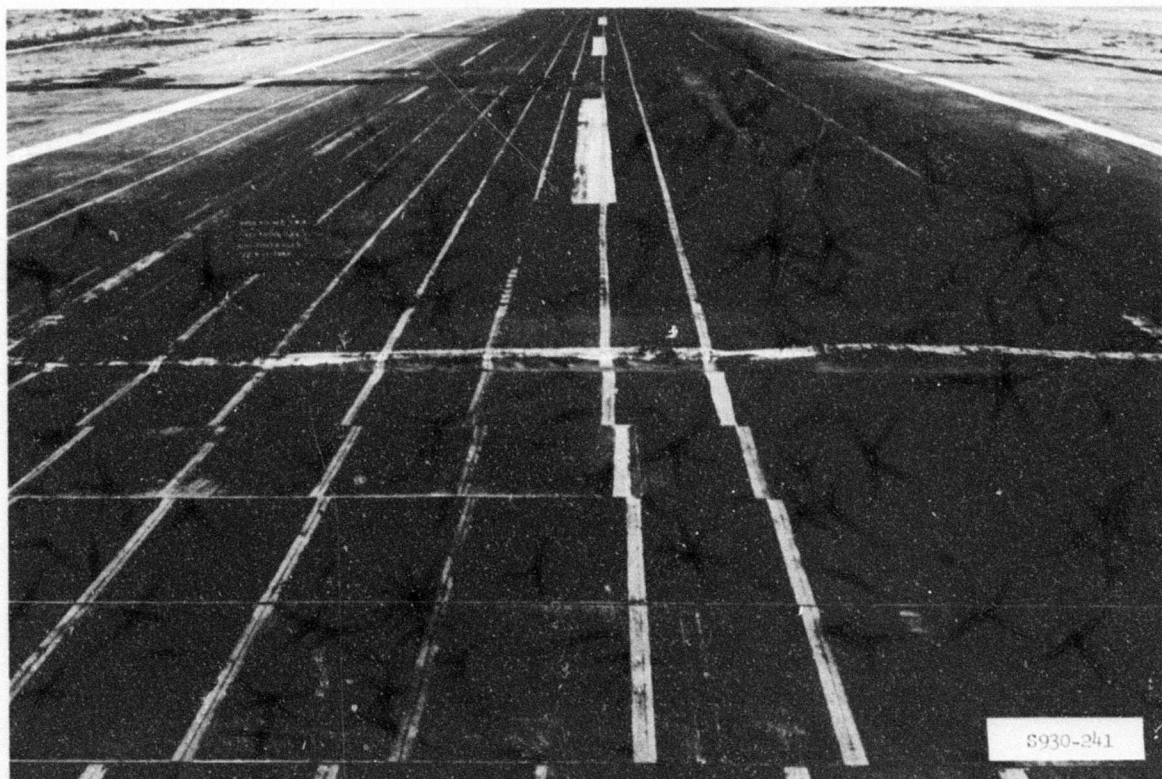
Photo 52. General condition of test section 1 after 400 coverages

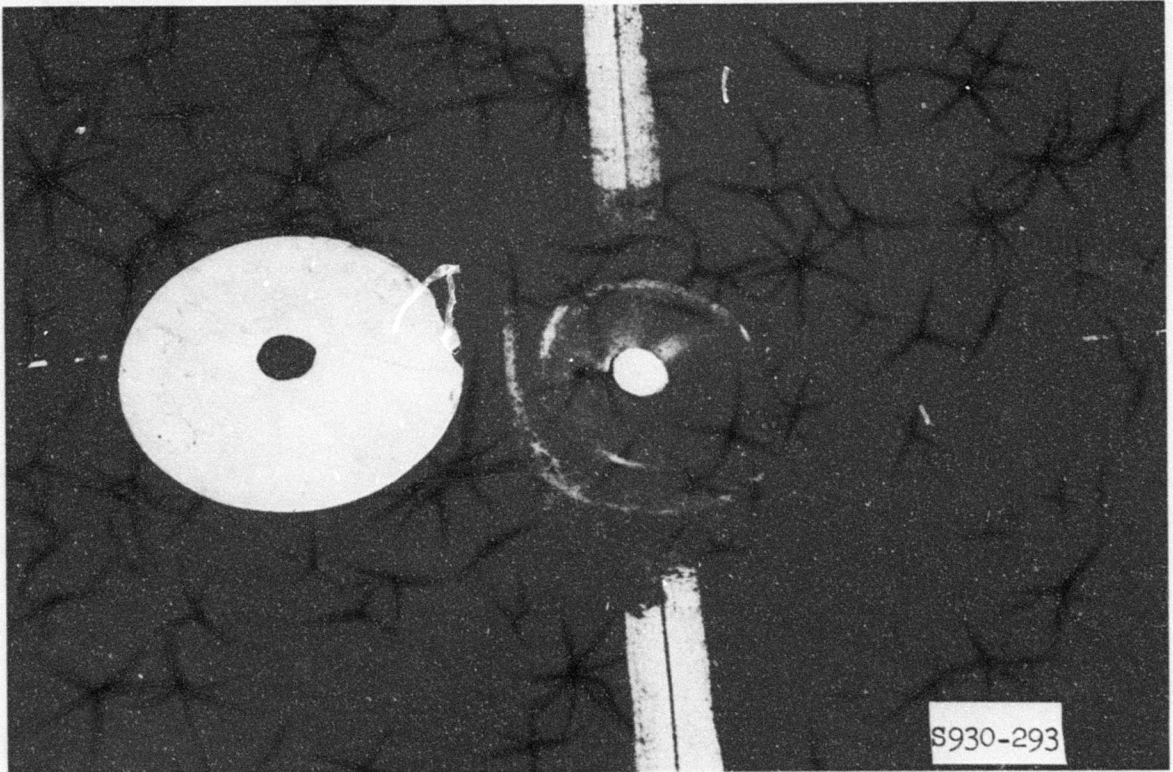
Photo 53. Failure of steel anchor at joint between sheets 2 and 3 of section 1 after 522 coverages
